Analysis of a low NO_x burner re-fit of a tangentially fired boiler

Dr. F. McKenty*, L. Gravel*, M. Mifujii**

This study concerns an existing 260 million BTU/hr tangentially fired process boiler which was re-fitted with a low NO_x natural gas firing system. The re-fit involved changing the burners, the windbox and the Air/FGR ductwork, as shown, with the boiler, in figure 1.

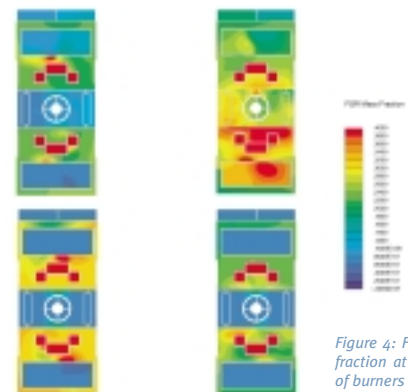
Figure 4: FGR mass fraction at the face of burners 1-4

pre-heated air stream is uneven. Figure 4 shows the FGR mass fraction distribution at the burner face. Burners 1 and 2 have FGR concentration distributions that vary widely from port to port. Burners 3 and 4 have near-homogeneous FGR distributions; these are the burners that are located on the far side of the boiler and so there is more space for the FGR and air streams to mix. Nevertheless, the average FGR mass fraction at burners 3 and 4 is only 7%, which places the Fuel/Air/FGR mixture in the pre-mixing chamber within flammability limits. The FGR distribution imbalance was thus demonstrated to be the source of the damage to the Fuel-Lean ports caused by the mixture igniting within the port. The specified design concentration for FGR of 13% would have made this situation impossible.

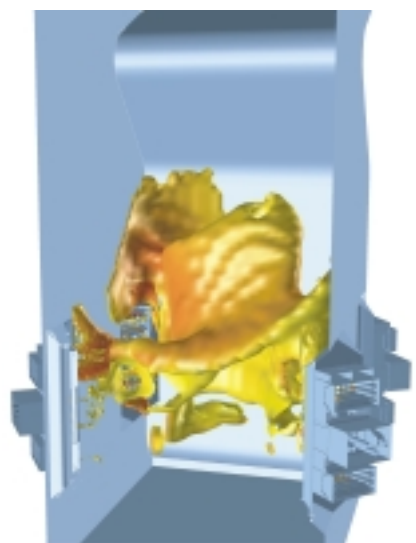
Figure 5: Luminous flame contour

Figure 5 shows the resulting fireball. It is asymmetrical (Figure 6) as the flame from the Fuel-Rich port of burner 2 is severely lifted due to the very high FGR concentrations. This behavior was confirmed by visual inspection of the fireball through the boiler view-ports. Figure 7 shows flames developing inside the upper Fuel-Lean port of burner 3; this is the ultimate cause of the damage.

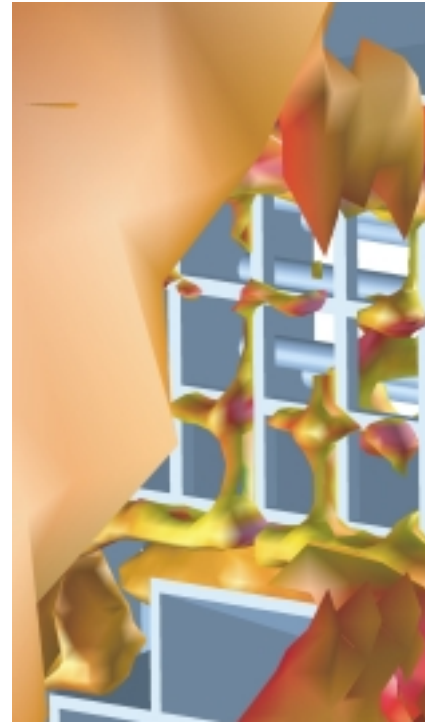
Fig7: Luminous flame contour – upper Fuel-Lean port – Burner #3

The STAR-CD simulations allowed BMA to pinpoint the cause of the damage as being the result of incomplete mixing of the pre-heated air and FGR streams. This mixing problem only presented itself on this small process boiler because the Air/FGR ductwork is considerably scaled down when compared to the larger installations where this technology had previously been installed. Consequently, the FGR stream has much less room to thoroughly

In summary, the STAR-CD simulations showed that a problem that was first thought to be the result a serious flaw in the burner design was instead linked to a simple imbalance in the FGR distribution. This was a very important conclusion as the problem was easily remedied once it was identified, but failure to balance the FGR distribution would have doomed any attempts to eliminate the problem by modifying the burner design. ■
