Analysis of a low NO_x burner re-fit of a tangentially fired boiler

Dr. F. McKenty*, L. Gravel*, M. Mifujii**

This study concerns an existing 260 million BTU/hr tangentially fired process boiler which was re-fitted with a low NO_x natural gas firing system. The re-fit involved changing the burners, the windbox and the Air/FGR ductwork, as shown, with the boiler, in figure 1.

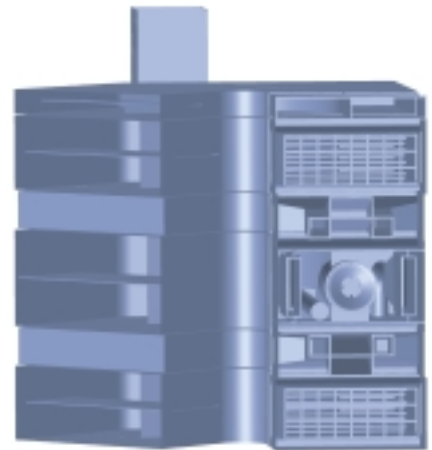
Figure 2: Tangentially fired burner

In order to determine if the combustion system had any operational difficulties when fired according to design specifications, BMA first carried out a detailed furnace simulation (3.6 million cells). Details of the burner and windbox are shown in figure 2. The burner is divided into six zones: a lower Fuel-Lean port with pre-mixing chamber, a lower pure re-circulated flue gases (FGR) port, a central Fuel-Rich port, an upper FGR port, an upper Fuel-Lean port and an Over-Fire-Air (OFA) port. The pre-heated combustion air is diluted with FGR prior to entering the windbox with an average FGR mass fraction of 13%. The first simulation was carried out at 100% load using boundary conditions corresponding to a homogeneous Air/FGR mixture entering the windbox.
